Facilities Conditions Review
September 15, 2025

Norman bird sanctuary

Facility Condition Assessment

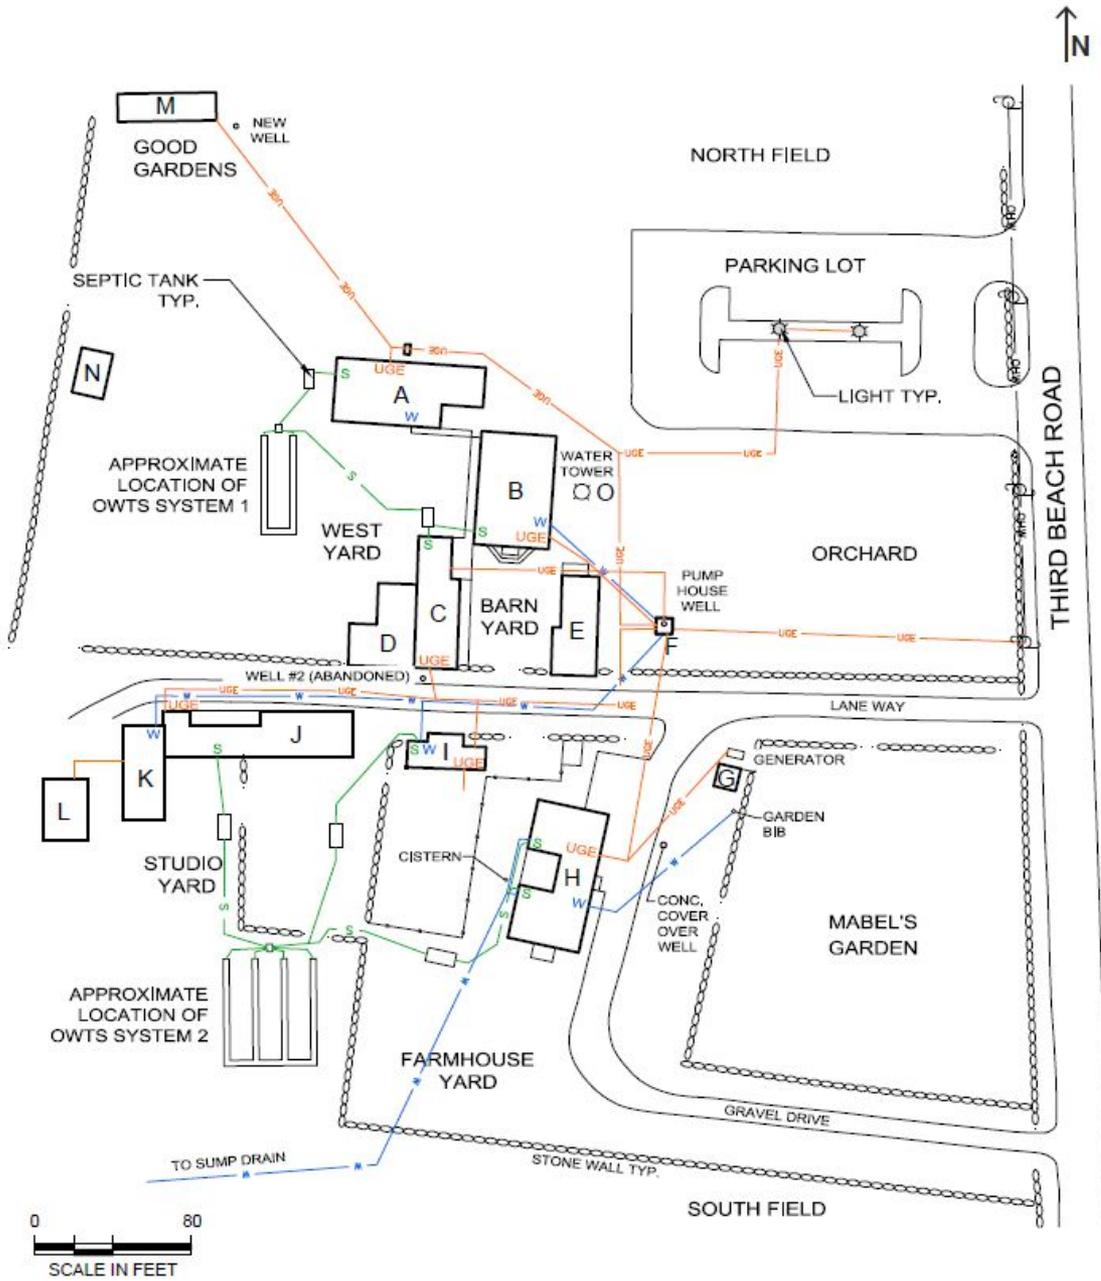
Existing Conditions | UTILITIES

- Confirm utilities locations
- Map water/drainage run-off

- Consider the implementation of some type of work order system.
- Secure vendor relationships for major building systems, on-call agreements, seasonal inspections.
- Update Building data sheets seasonally.
- Verify utility plan (2016), add water drainage.
- Consider securing space for the consolidation of Harvest Fair equipment. Impact is significant to existing facilities and their efficiency.
- Develop/Drill an Emergency Action Plan (EAP)
- Begin the process to develop a landscape master plan and guidelines.
